Management of Reed's Historic Resources

3.1 OVERVIEW

Management Guidelines for Campus Buildings

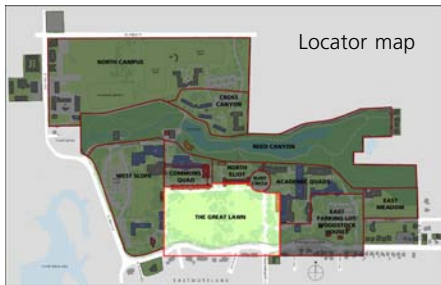
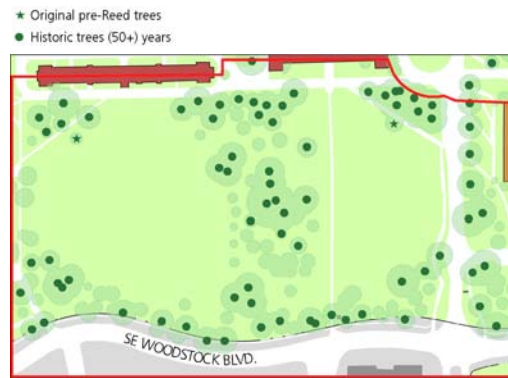
The Great Lawn landscape area.

- Maintain the Great Lawn as a significant open space on campus.
- Maintain existing tree-to-open space ratio, and existing tree clusters.
- Maintain integrity of the lawn area by prohibiting new pathways and permanent structures/monuments.
- Maintain existing view corridors in all directions.
- Appropriately manage and protect the historic trees.
- Restrict understory plantings.
- When necessary due to health, condition or age, replace existing trees with specimens of the same genus and species, if possible.

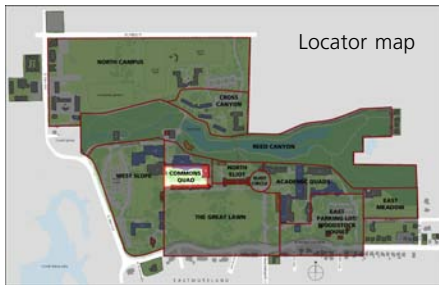
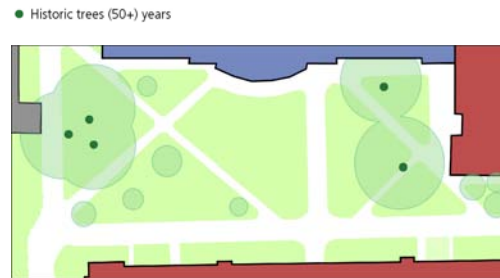
The Commons Quad landscape area.

- Protect the current configuration of the Commons Quad as an important physical and social space on campus.
- Maintain existing tree-to-open space ratio, and existing tree clusters.
- Maintain current system of pathways, including width, alignment and materials.
- Maintain integrity of the lawn area by restricting new pathways and permanent structures/monuments.
- Appropriately manage and protect the historic trees.
- Restrict understory plantings in the lawn. Foundation plantings along the buildings are acceptable.
- When necessary due to health, condition or age, replace existing trees with specimens of the same genus and species, if possible.

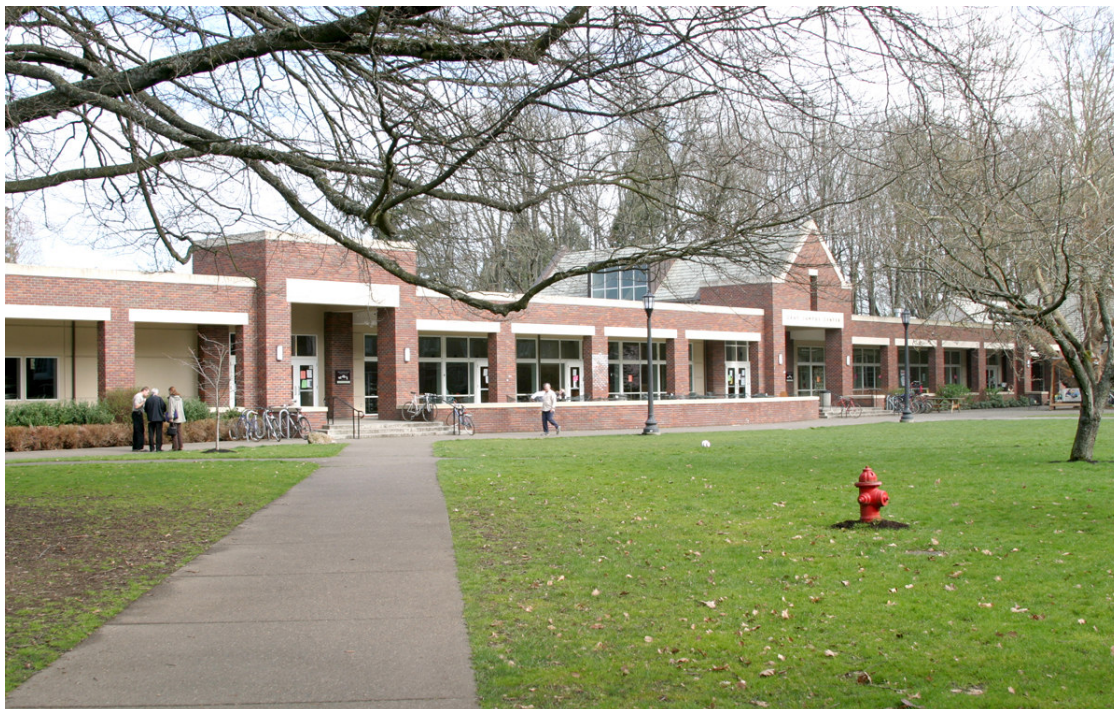
The Commons Quad, with the Gray Campus Center in the background.

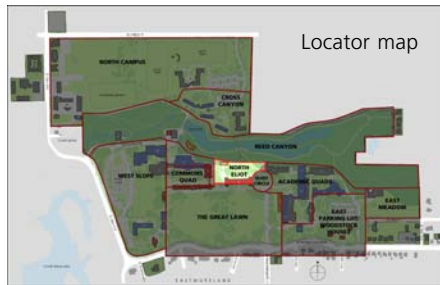
- ★ Original pre-Reed trees
- Historic trees (50+ years)

North Eliot landscape area.

- Appropriately manage and protect the pre-Reed and historic trees.
- Maintain the woodland edge along the canyon.
- Maintain existing tree-to-open space ratio, and tree clusters.
- Maintain integrity of the lawn area by restricting new pathways and permanent structures/monuments.
- Restrict understory plantings in the lawn. Foundation plantings along the buildings are acceptable.

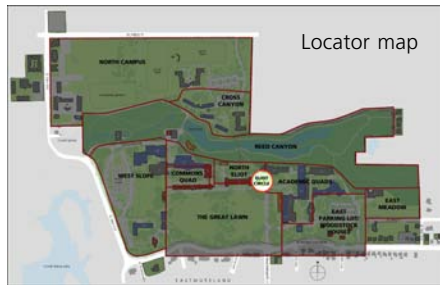
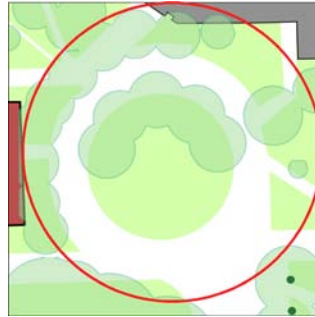
Eliot Circle landscape area.

- Retain this area's distinct circular shape.
- Maintain the existing tree configuration.

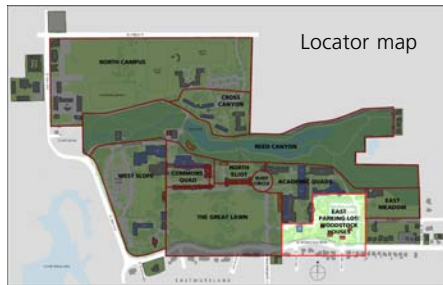
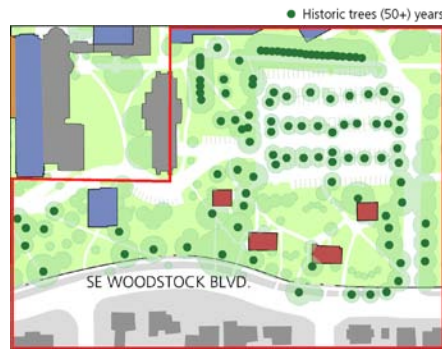
The East Parking Lot/Woodstock Houses landscape area.

- Appropriately manage and protect the historic trees south of the driveway and parking lot.
- Reinforce the woodland shade garden along SE Woodstock Boulevard (understory plantings desired here).
- Maintain the 'soft' residential edge by establishing a setback zone for any new buildings along Woodstock Boulevard.
- Protect and maintain the historic nursery trees through professional care and proper horticultural practice. If necessary due to health, condition or age, do not replace existing trees with specimens of the same genus and species. These trees are a unique and singular feature, and perpetuation beyond their natural life span is not desired.

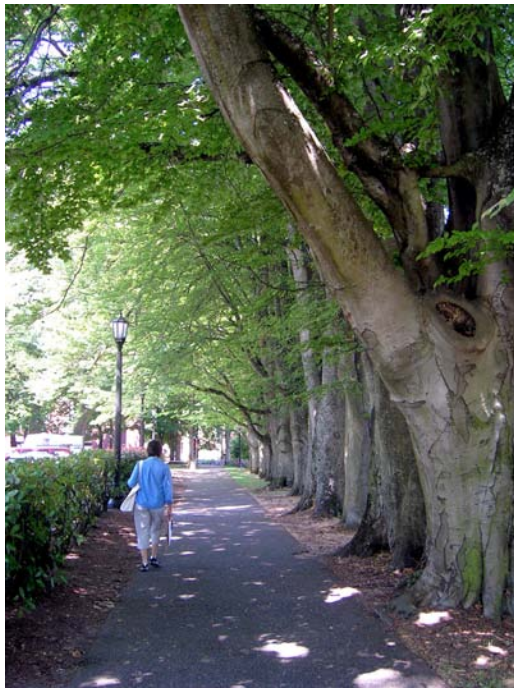
Original nursery trees planted in close proximity to each other now form an alley (an alignment of trees).

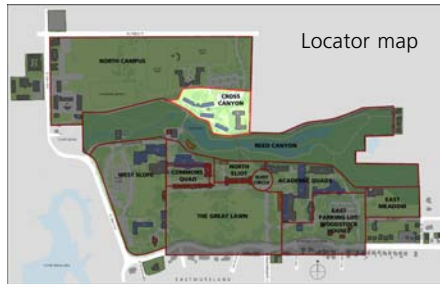
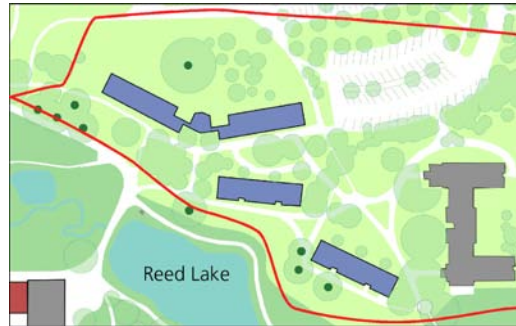
Cross Canyon landscape area.

● Historic trees (50+ years)

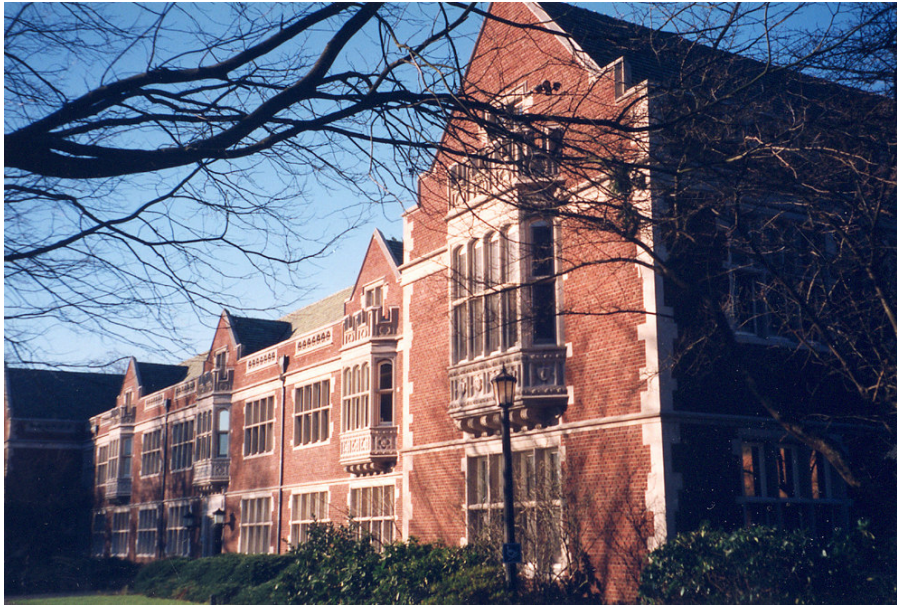
The south facade of Eliot Hall.

- Red brick, English bond pattern, with wide, raked grout joints. Trimmed with flat and carved limestone
- Green slate roof

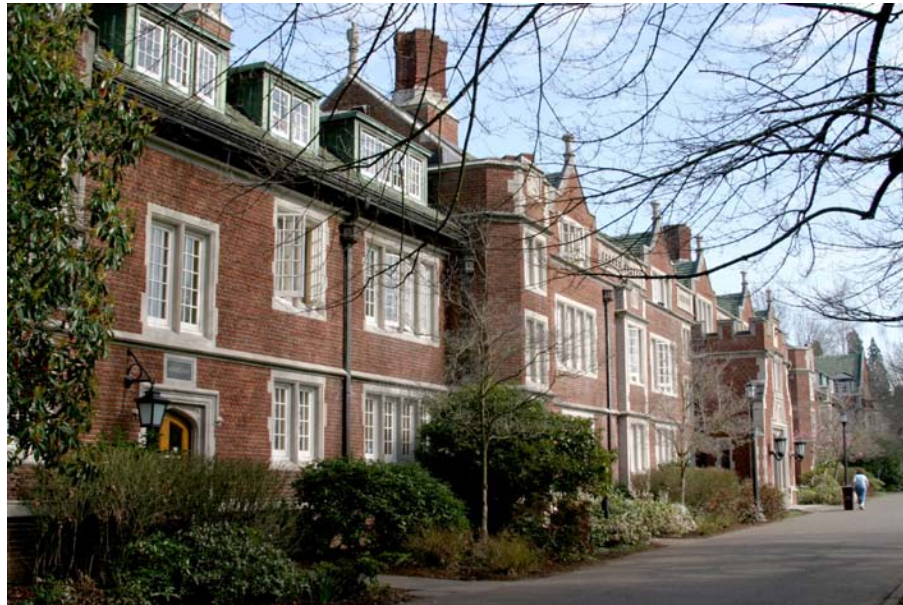
Old Dorm Block's south facade.

- Red brick, English bond pattern, with wide, raked grout joints. Trimmed with flat and carved limestone
- Green slate roof with copper-walled dormers
- Long, narrow form with a central sally port

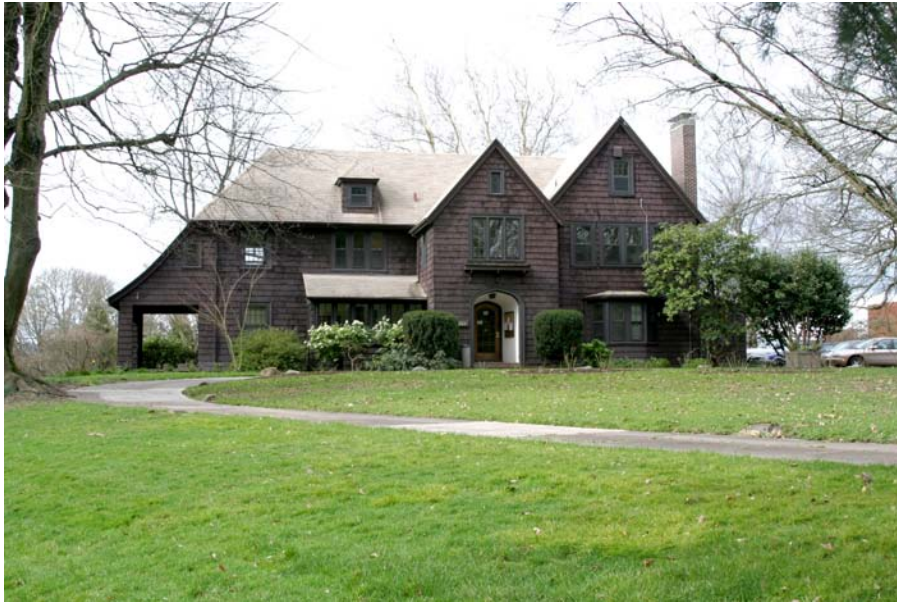
The main facade of Prexy which fronts the Great Lawn.

- Wood shingled walls
- Many and varied roof types with three chimneys

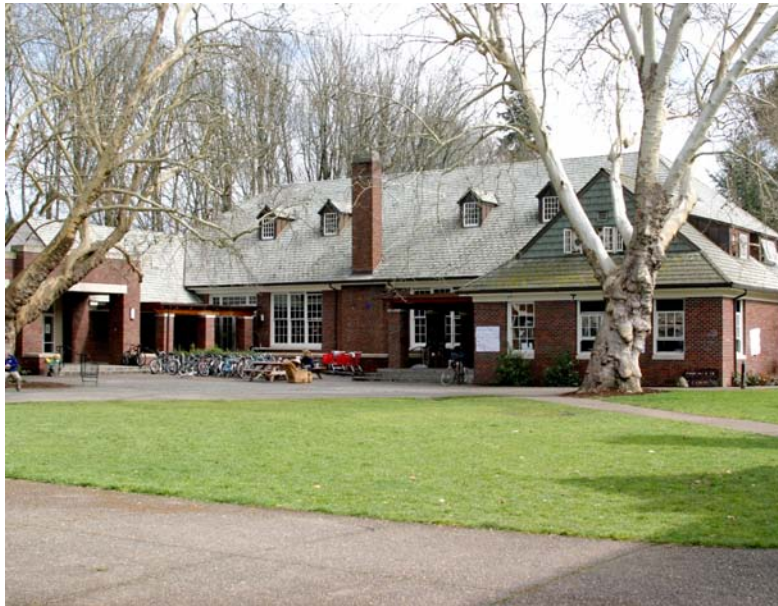
The Student Union, as viewed from the Commons Quad.

The interior retains much of its historic character.

- Review the *Secretary of the Interior's Standards* when planning remodeling projects.
- Maintain all exterior building elements in good repair, protecting from harmful effects of weather.
- Protect the original form of the building on the west, south and east sides, avoiding intrusive additions.
- Maintain the central gathering hall and all the materials therein.

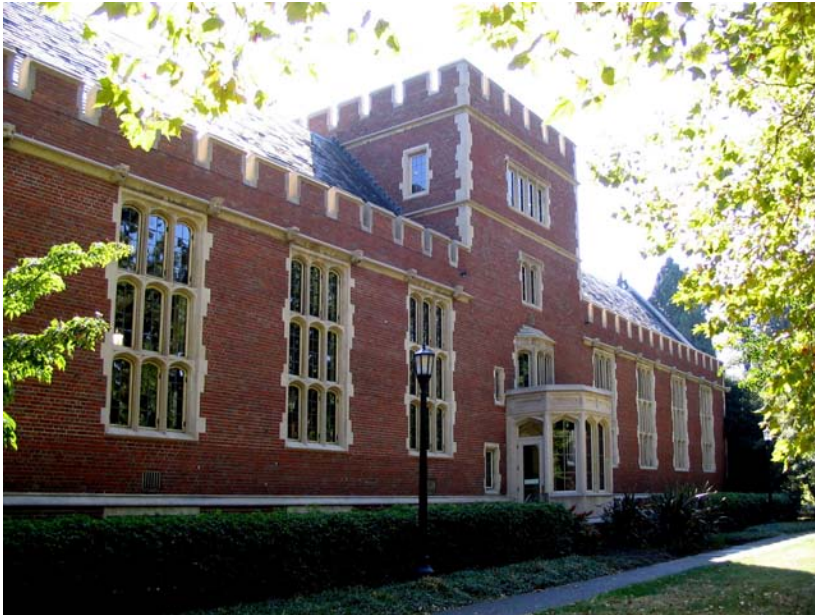
Hauser Library.

- Review the *Secretary of the Interior's Standards* when planning remodeling projects.
- Maintain all exterior building elements in good repair, protecting from harmful effects of weather.
- Protect the original form of the building at the west, south and north sides, avoiding intrusive additions.
- Maintain view corridors to and from the Great Lawn.
- Retain the layout and character of the interior spaces.

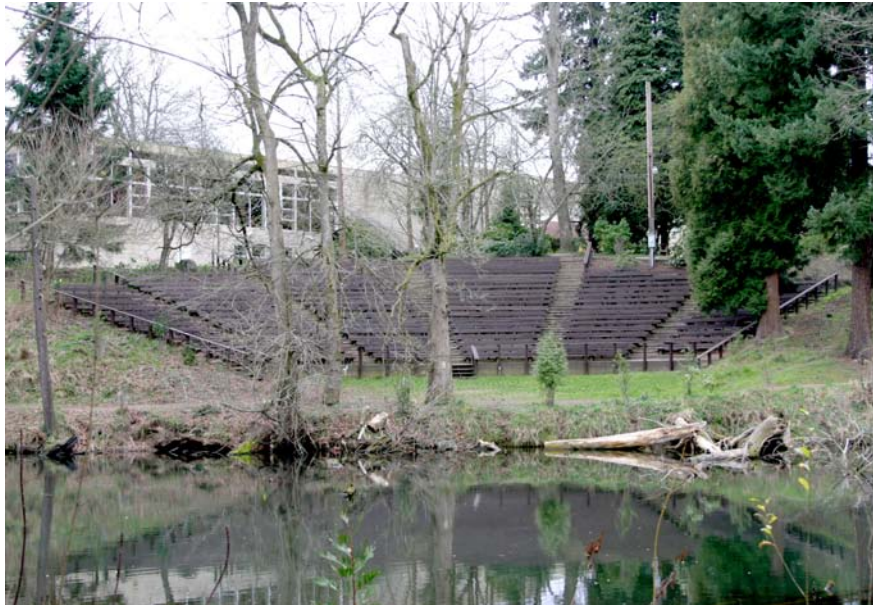
View towards the Cerf Amphitheatre from across Reed Lake.

- Review the *Secretary of the Interior's Standards* when planning remodeling projects.
- Maintain in good condition all wood elements through periodic cleaning and painting.
- Keep seating area and stage lawn free from invasive vegetation.
- Maintain view corridors to and from Reed Lake.

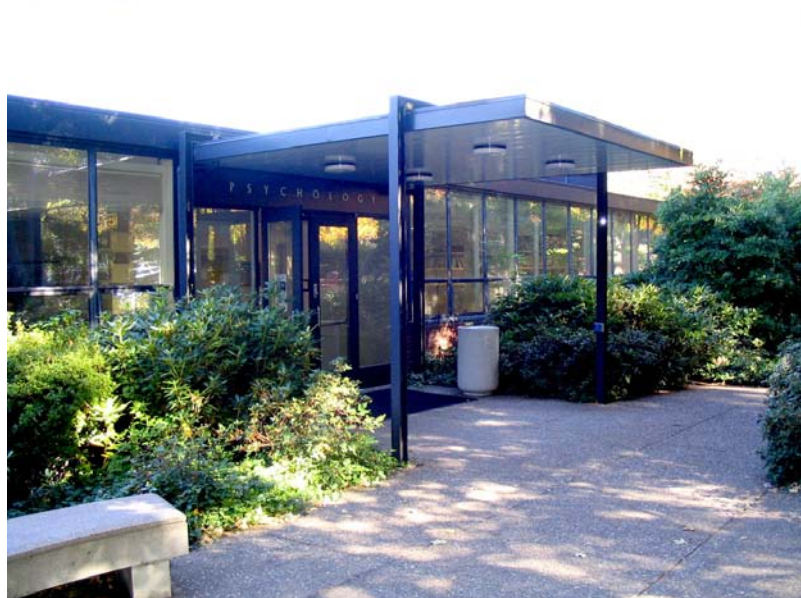
The main entrance into the Psychology Building.

- Review the *Secretary of the Interior's Standards* when planning remodeling projects.
- Maintain all exterior building elements in good repair, protecting from harmful effects of weather. Be attentive to maintaining the steel in the window wall system.
- Protect the original form and low-rise nature of the building, an important and defining characteristic.

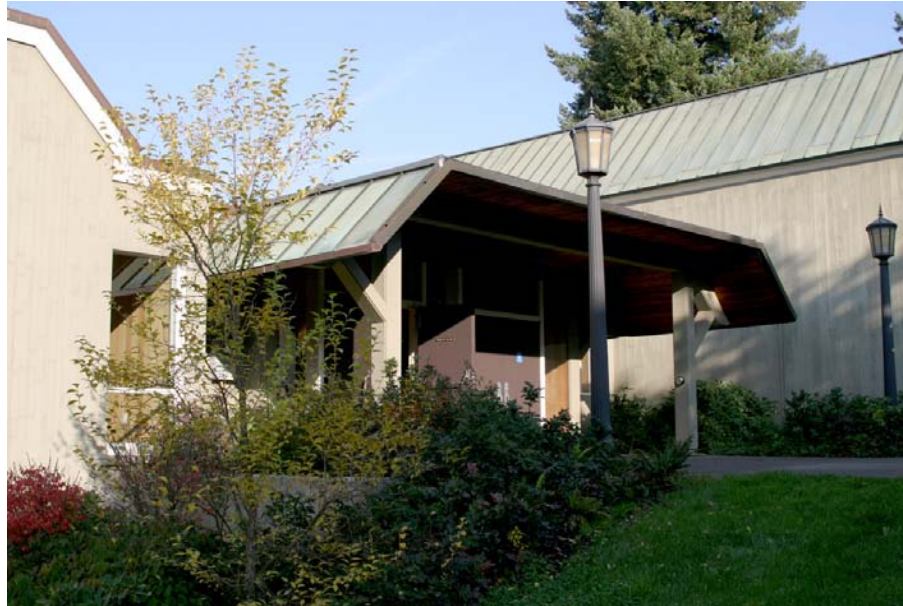
The Sport Center's main entrance.

- Review the *Secretary of the Interior's Standards* when planning remodeling projects.
- Maintain all exterior building elements in good repair, protecting from harmful effects of weather.
- Protect the building's form and materials, avoiding intrusive additions (recent additions have been well handled and do not call attention to themselves).

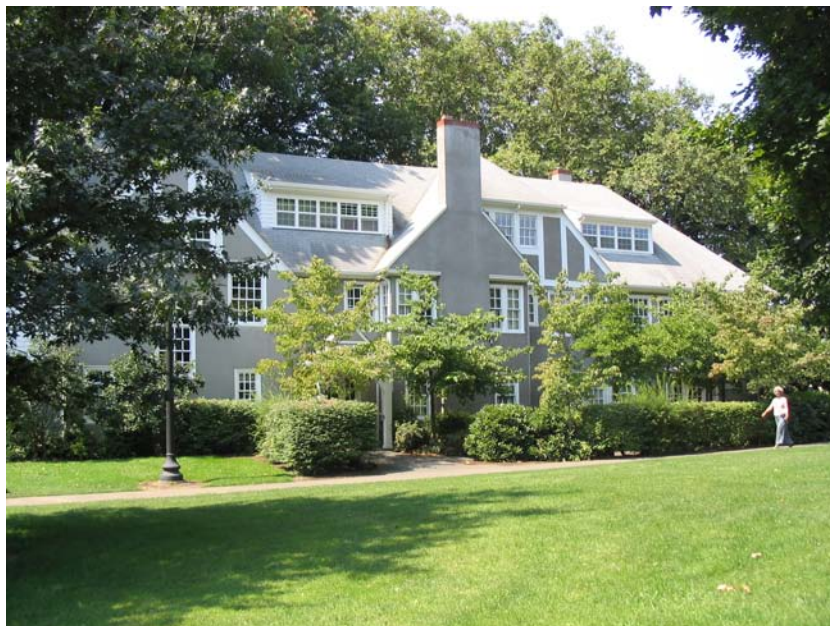
Anna Mann received a large addition in 1992, which extended the building southwards, starting from just left of the chimney.

- Stucco with half timber detailing
- Many and varied roof types
- *note: most all windows are not original, but have been replaced in keeping with the building's original style*

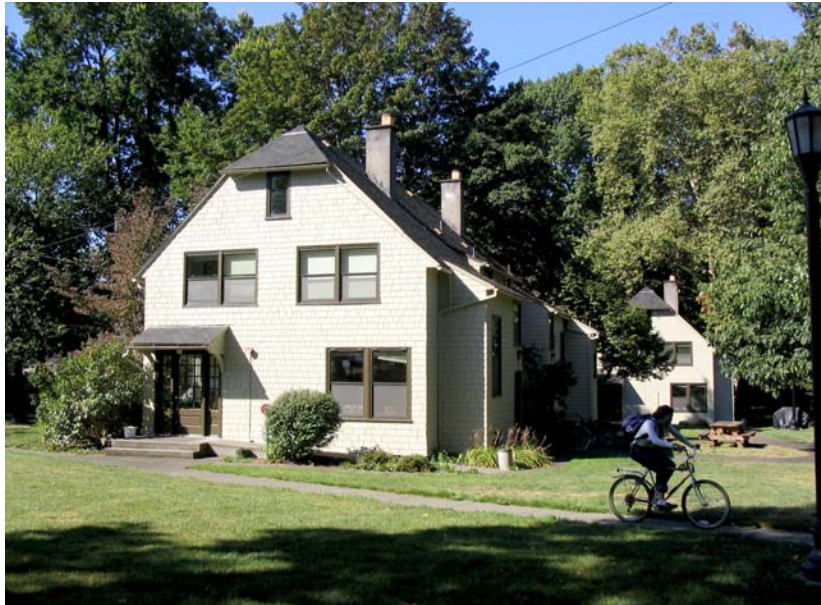
Woodstock III (foreground)
and Woodstock II.

- Maintain all exterior building elements in good repair, protecting from harmful effects of weather.
- Protect the form and massing of the buildings, avoiding intrusive additions.
- Maintain the existing site relationship between the four buildings.
- Retain the layout, character, and original materials of the interior spaces.

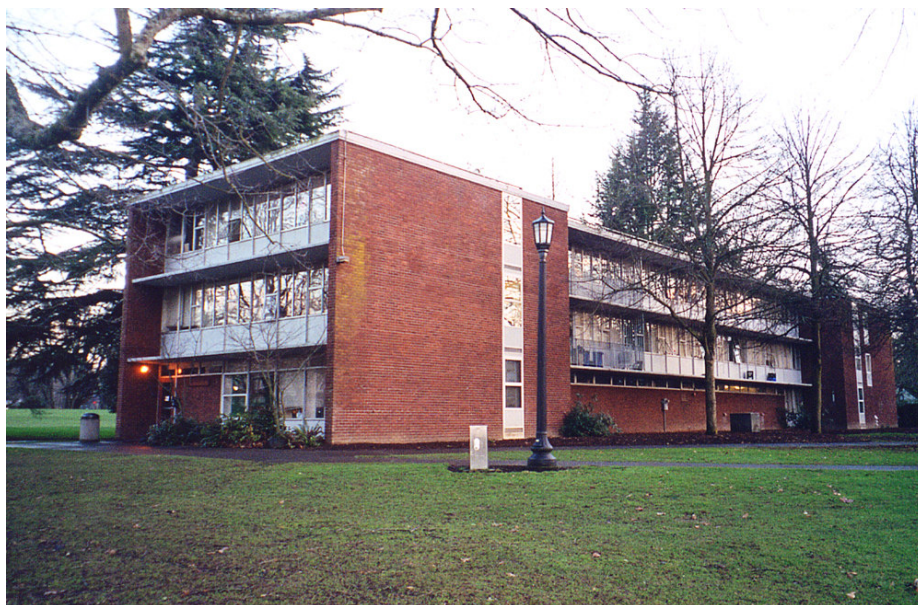
North and west
facades of
MacNaughton Dorm.

- Maintain all exterior building elements in good repair, protecting from harmful effects of weather.
- Maintain view corridors to and from The Great Lawn and the lower West Slope.
- Retain the interior brick feature walls.

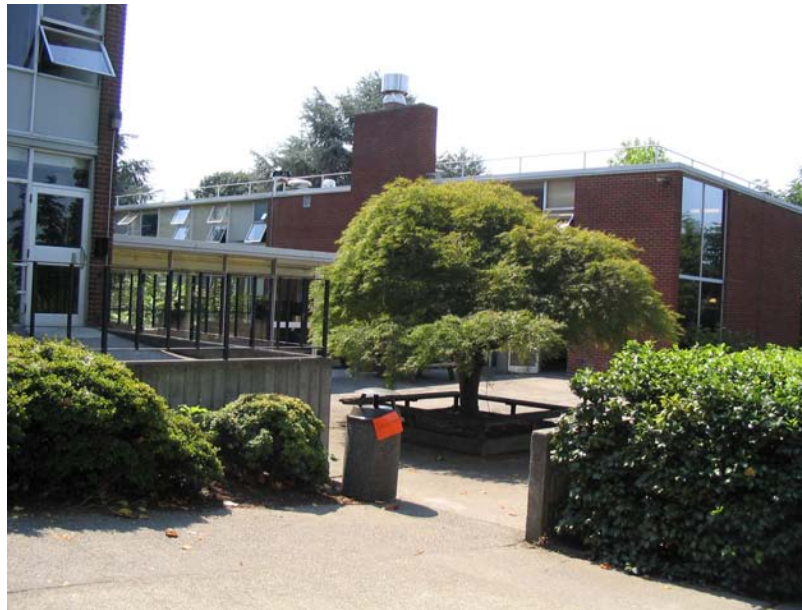
Foster (left) and Scholz (right) dormitories connected via a glazed social area.

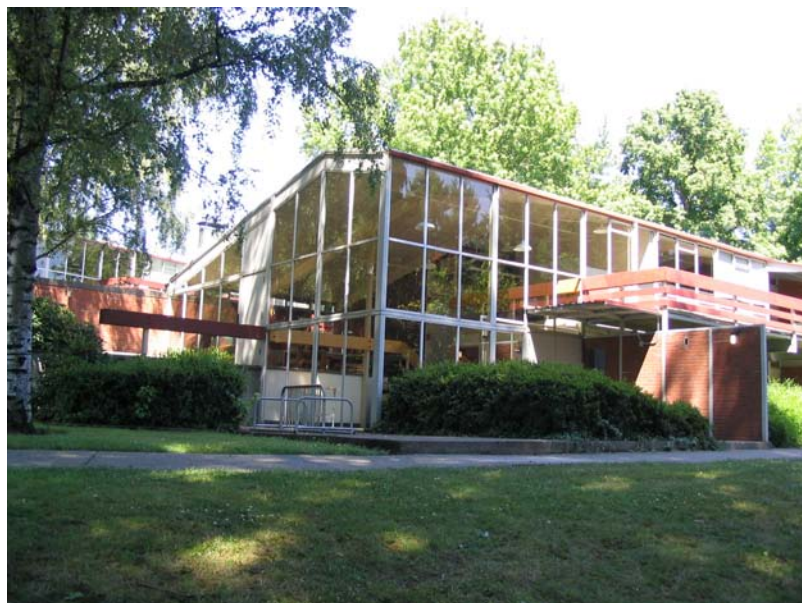
Woodbridge Dorm, one of the four residence halls within the Cross Canyon complex.

- First floor double loaded corridors, no corridors on second floor
- Interior walls of brick
- Split level social rooms

Conversely, the Cross Canyon dorms are well regarded and well used, but are beginning to show deterioration due to failed envelope systems (the windows in particular). This is an example of the need for an in-depth

condition assessment study that explores methods of upgrading building systems while retaining historic character.

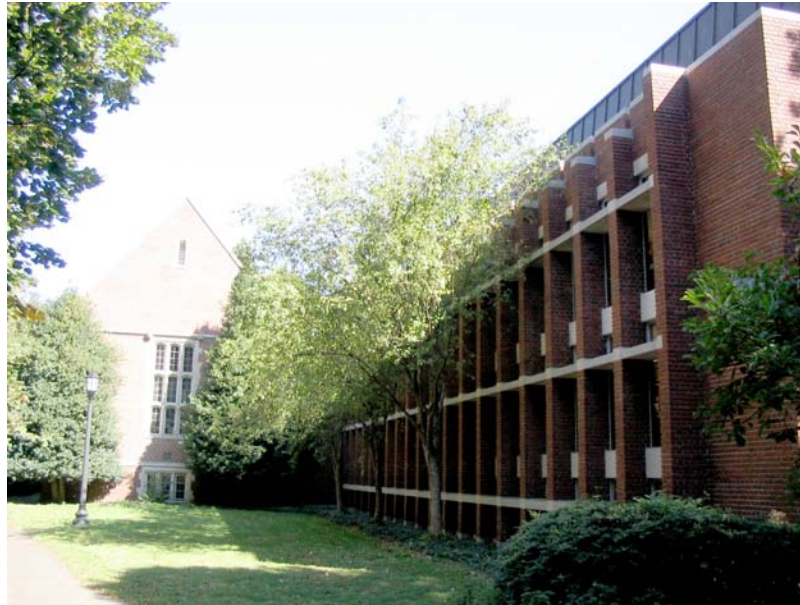
The Hauser Addition, with its brick piers, precast details, and copper mansard roof.

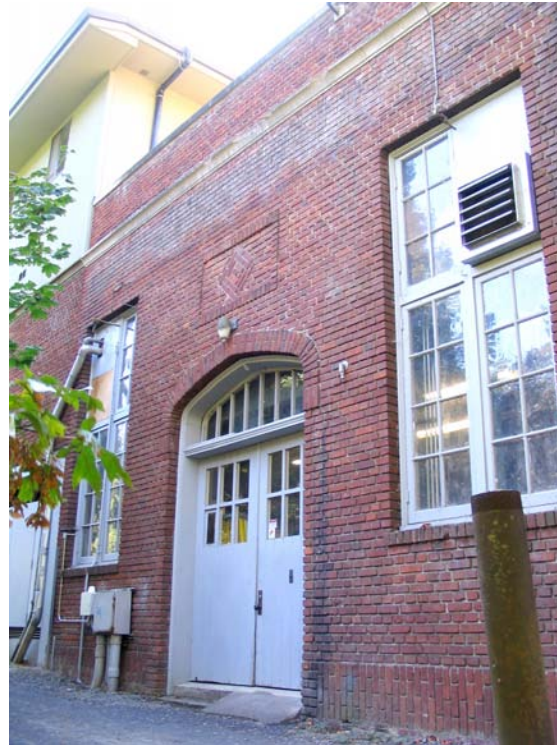
North facade of the Power House, with original entry doors and transom.

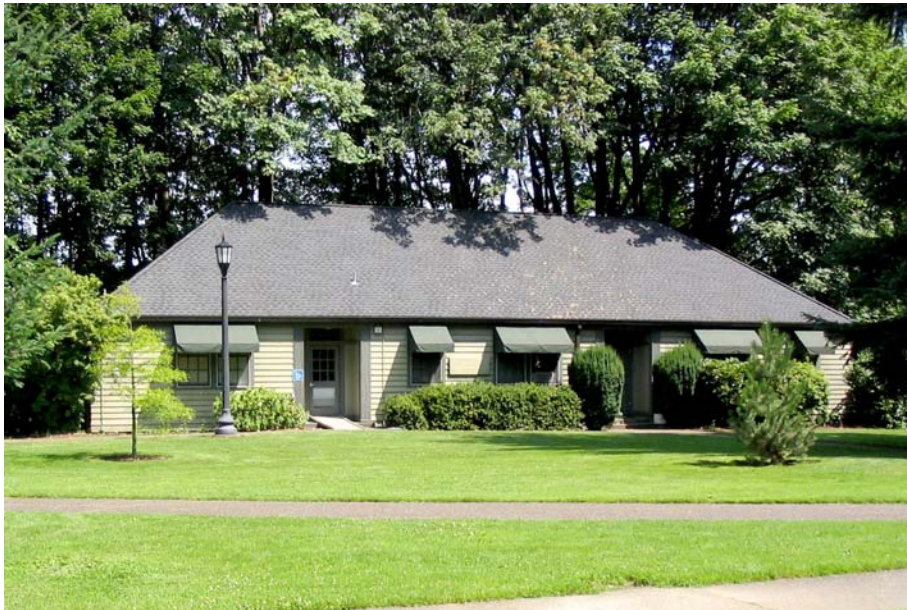
The Health and Counseling building, which in 1960 received a fairly substantial addition to the west.

- Maintain all exterior building elements in good repair, protecting from harmful effects of weather.
- Maintain view corridors to and from North Eliot and Reed Canyon.
- The Health and Counseling building's historic character was compromised by a substantial addition in 1960, somewhat imperceptible since it was done in a complimentary style. Since this addition was completed within the period of historic review (up to 1967), it is considered to be of historic vintage. Any future changes to the building form should be done mindful of the building's existing character.

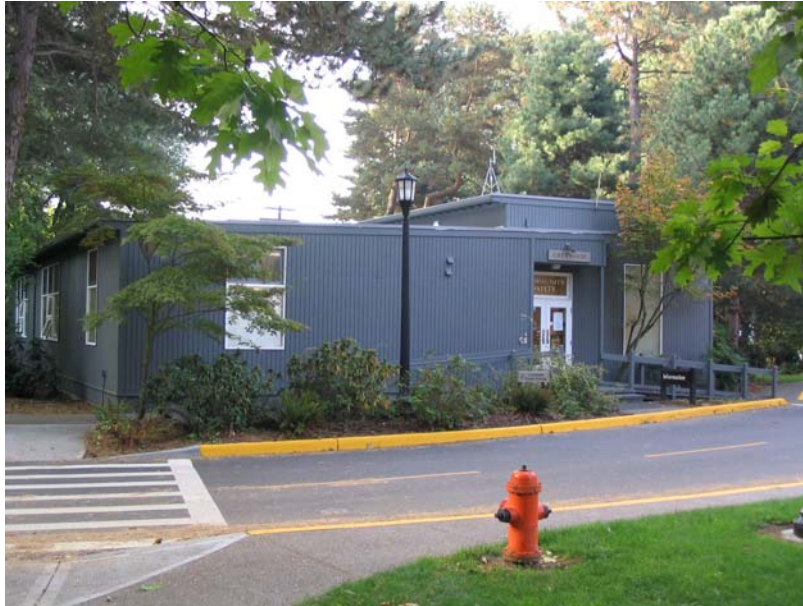
The current configuration of Greywood is but a portion of its original size when moved to this site in 1946.

- Maintain all exterior building elements in good repair, protecting from harmful effects of weather.
- This property was moved to this site in 1947, and severely altered in 1980. As such, it retains little of its original historic character.

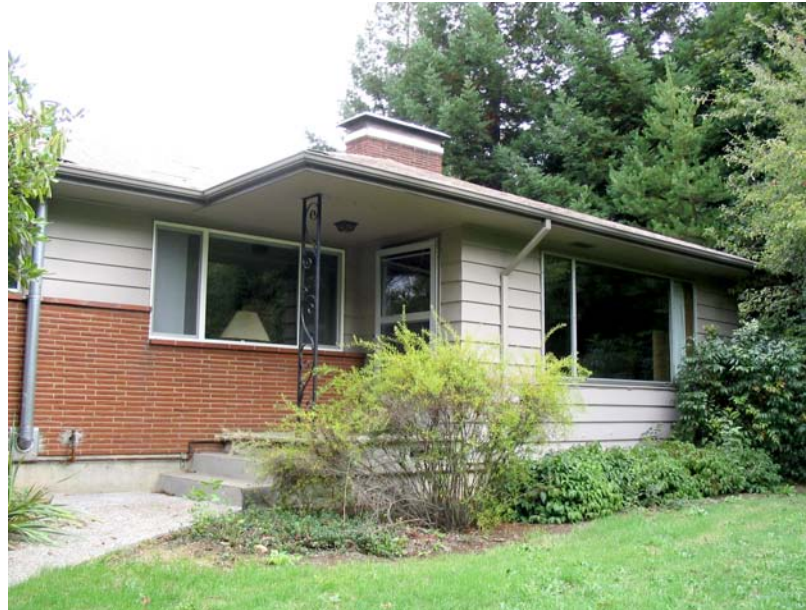
Chinese House was originally a single family residence, purchased by Reed in 1986 to house students in the Chinese language program.

- Maintain all exterior building elements in good repair, protecting from harmful effects of weather.
- This building contains minimal significance to the history of Reed College, and as such requires no special treatment.

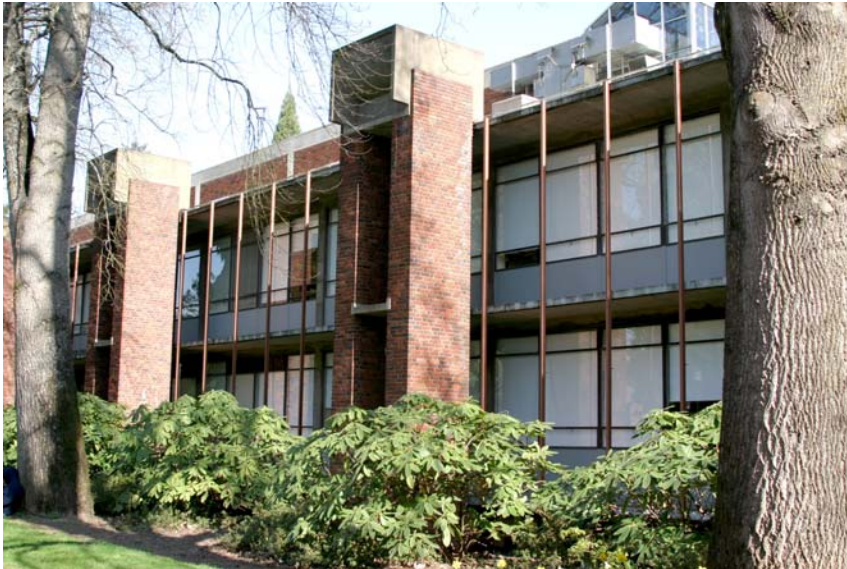
The curtain wall system (minus the original metal screens) sits behind the brick ventilation stacks.

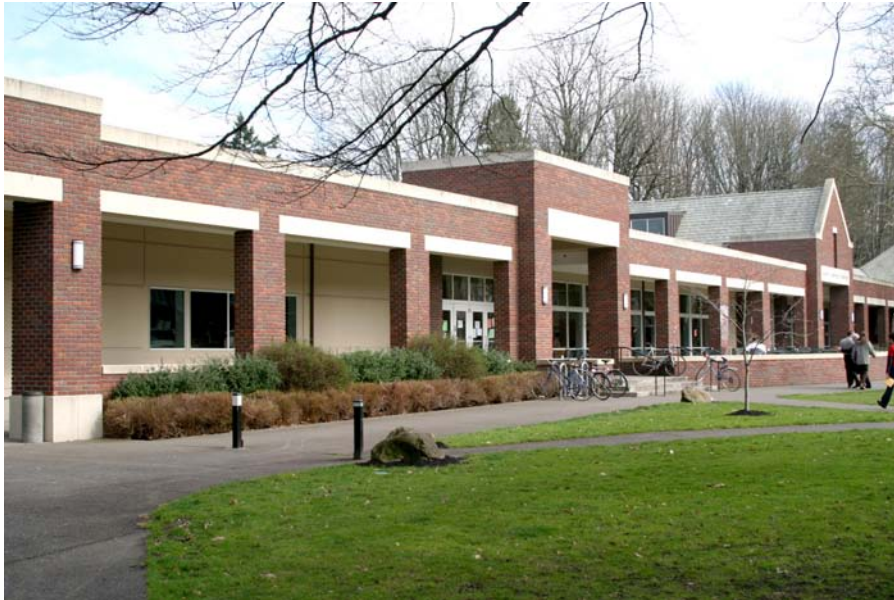
The exterior of the Gray Campus Center was extensively remodeled in the 1990s, replacing all of its exterior materials.
